TOWN OF LINCOLN

Statement of Interest for the Lincoln School, Lincoln, MA

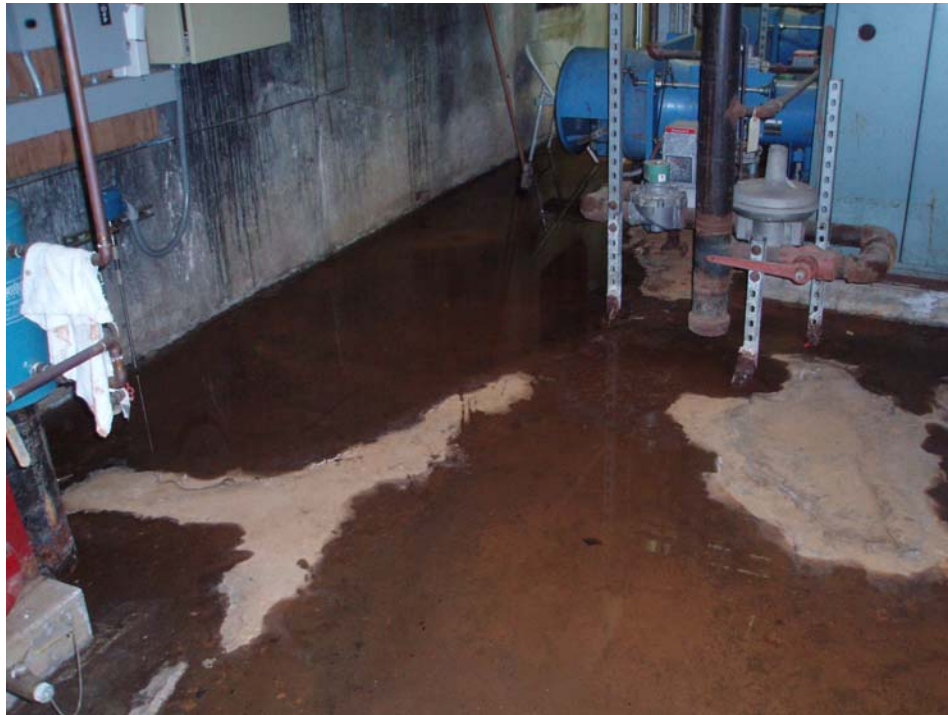
1. Ground Water. The Lincoln Campus is constructed on low-lying, filled ground next to a tributary of the Cambridge Reservoir, a public water supply. The water table rises to within a few feet of the surface, and the site is relatively flat, allowing for little natural drainage. The oldest portion of the Smith Building, constructed in 1948, has a heating plant based on two boilers in a basement boiler room whose floor is 10 feet below ground level. During the majority of the year water flows into the basement through cracks in the old slab, and sometimes directly through a connection to the partial crawlspace under the Smith Building. Picture 1.11 shows the results: a floor which is constantly wet. Pictures 1.12 and 1.13 show water bubbling up out of a crack in the floor to the height of 2-1/2", and some of the damage caused by a flood in 2006. The flood waters rose to a height above the burners, damaged the fire eyes and control systems, and reduced the efficiency of both boilers. One similar flood was reported occurring in 1990, two years after the boilers were installed; six events have occurred during the past 25 years. In 2010, a heavy rainfall resulted in the flood inflow exceeding the sump pump capacity; the boiler room flooded to a height of 54" above the floor, damaging controls and burner units. Picture 1.14 shows the flooded Smith Boiler Room. In addition, the high water table has created septic problems and mold issues, as discussed in Problem Area 10 below.

Picture 1.11. View of Smith basement boiler room, showing water infiltration.

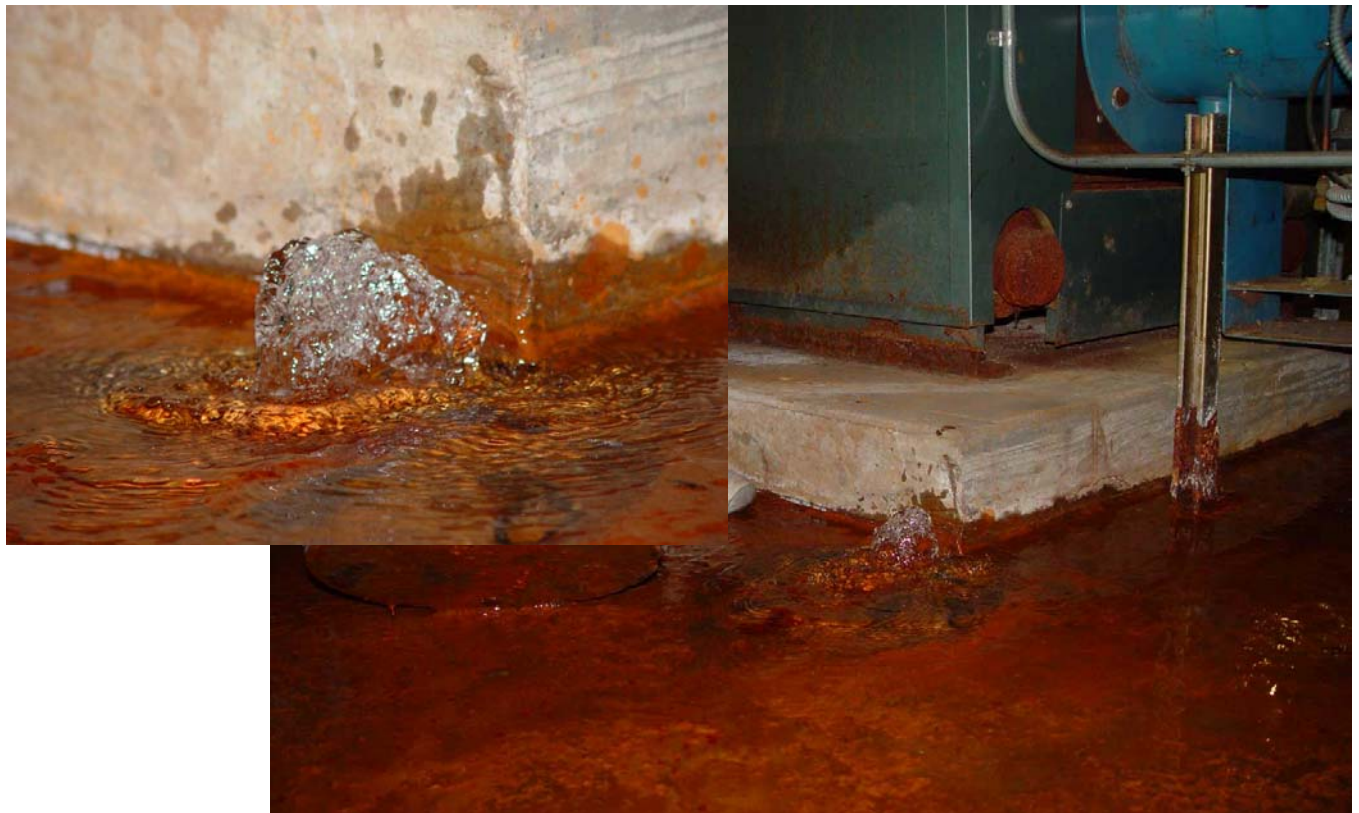
Picture 1.12. Smith basement, showing water damage to boiler (typical)

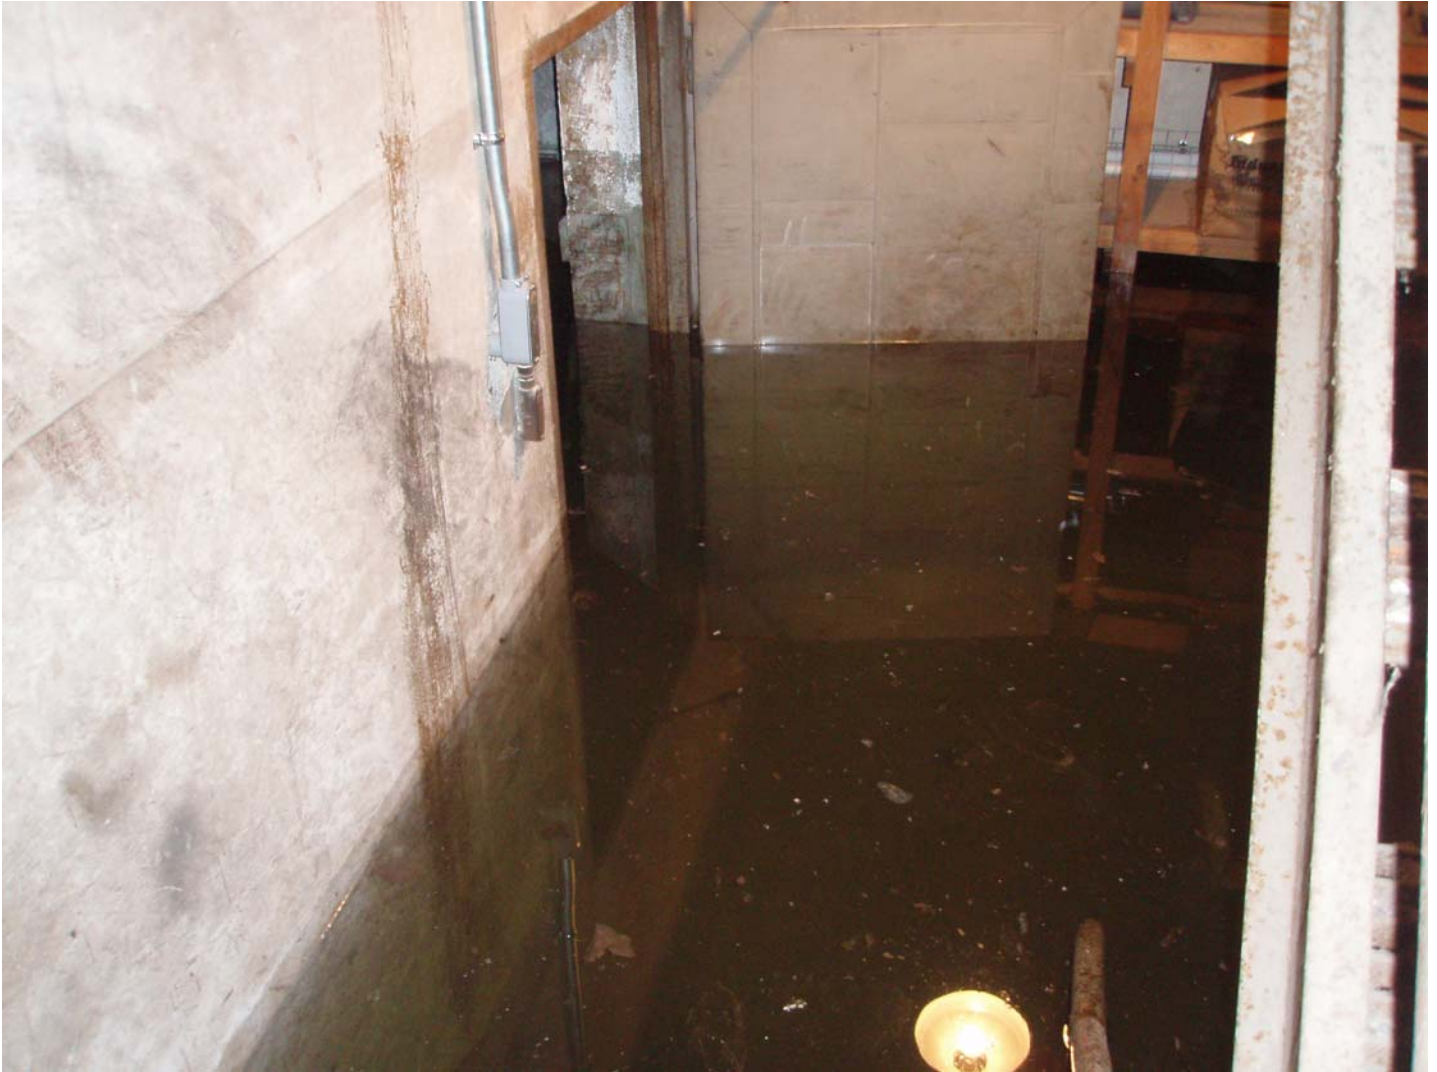
Picture 1.14. View of stairwell to the Smith basement taken on March 15, 2010. Water is 53 inches above the floor level.

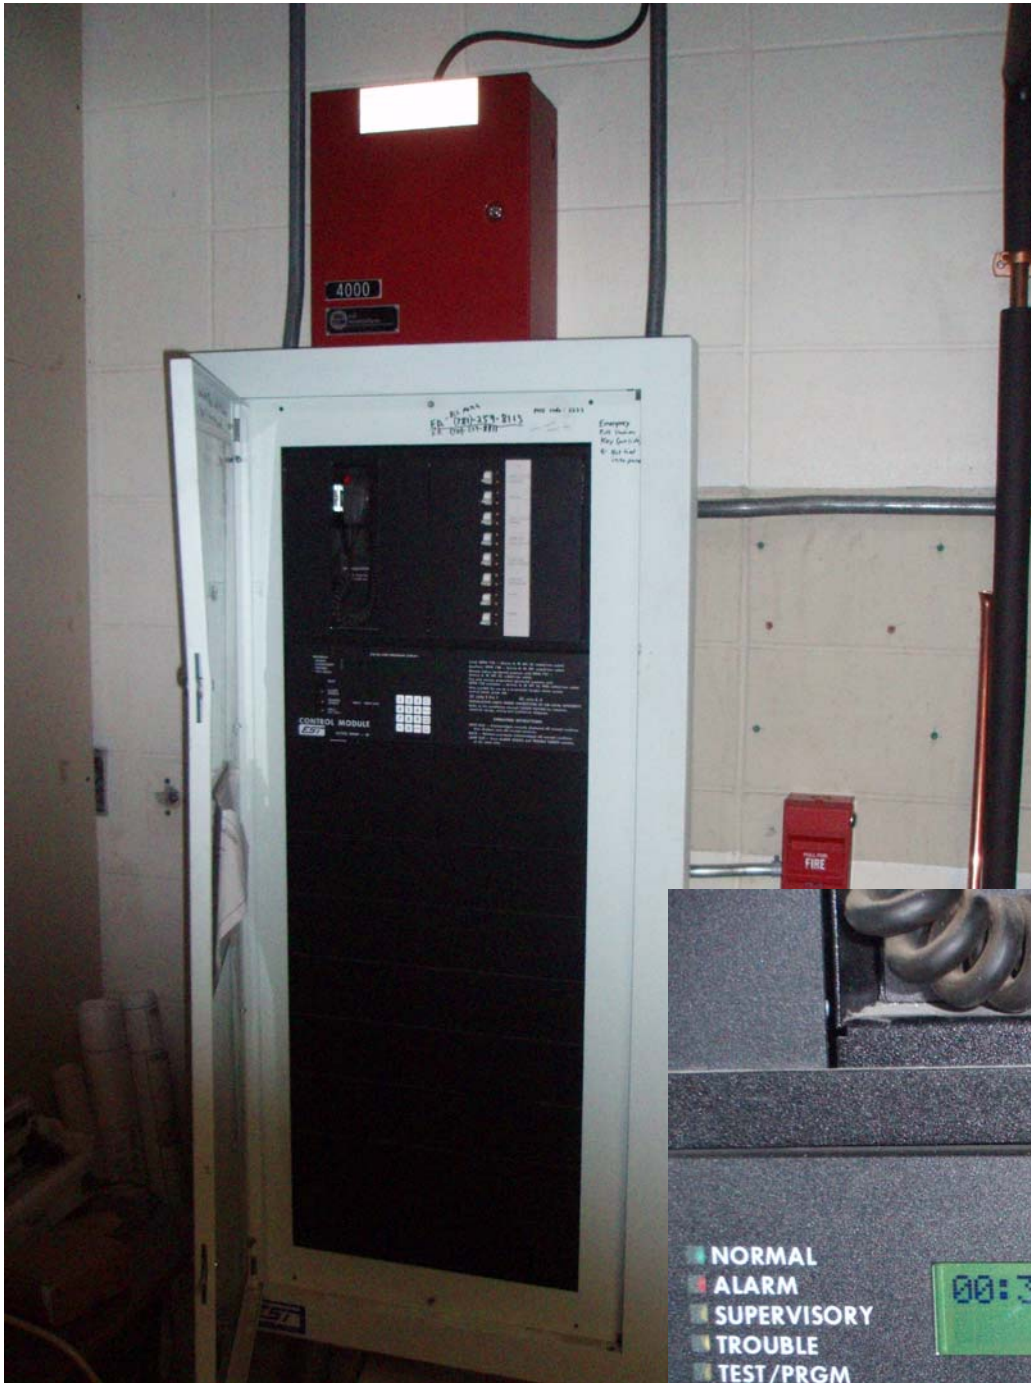
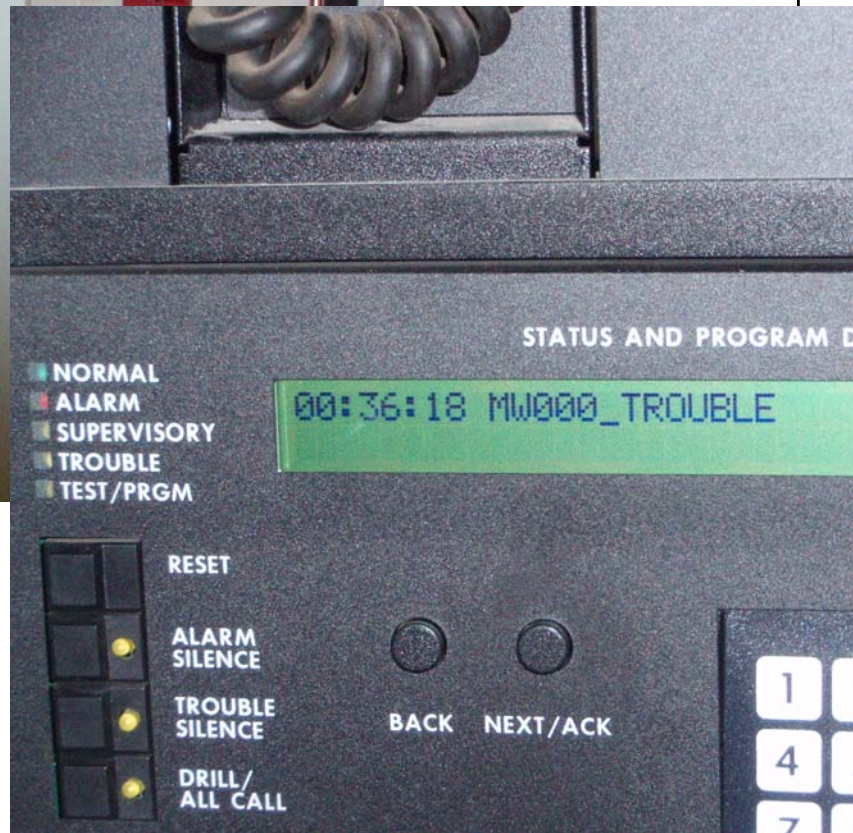
The Lincoln Fire Department recommends replacing the fire alarm master panel (picture 1.21) with a more reliable communications system. The panel is obsolete and no longer supported; it will communicate only with analog fire detection sensors. The District anticipates that the Town will provide funds to replace the panel in FY13 with one that will communicate with both analog and digital sensors. A fire in 2008 in one of the science laboratories underscores the importance of quick notification and easy egress, and pointed out how easily a fire can engage the mostly-wooden structure. The School Committee considers this a major area of risk.

Picture 1.21. Fire Alarm main panel, next to Brooks office, in trouble condition (typical). The District anticipates that the Town will provide funds to replace the panel in FY13 with one that will communicate with both analog and digital sensors, which could alleviate a significant portion, but not all, of the system problems.

2. Structure and Safety. The frequency of fire detection system inspection and servicing was increased from annually to quarterly, and problems with the alarm system receive immediate attention and response from our alarm contractor. Fire drills for students, faculty and staff are discussed and practiced frequently. The alarm contractor has expressed concern that the fire panel program may not restore properly in the event of a power failure, so contingency plans for fire watches have been discussed with the Fire Chief. The District anticipates that the Town will provide funds to replace the panel in FY13 with one that will communicate with both analog and digital sensors, which could alleviate a significant portion, but not all, of the system problems.

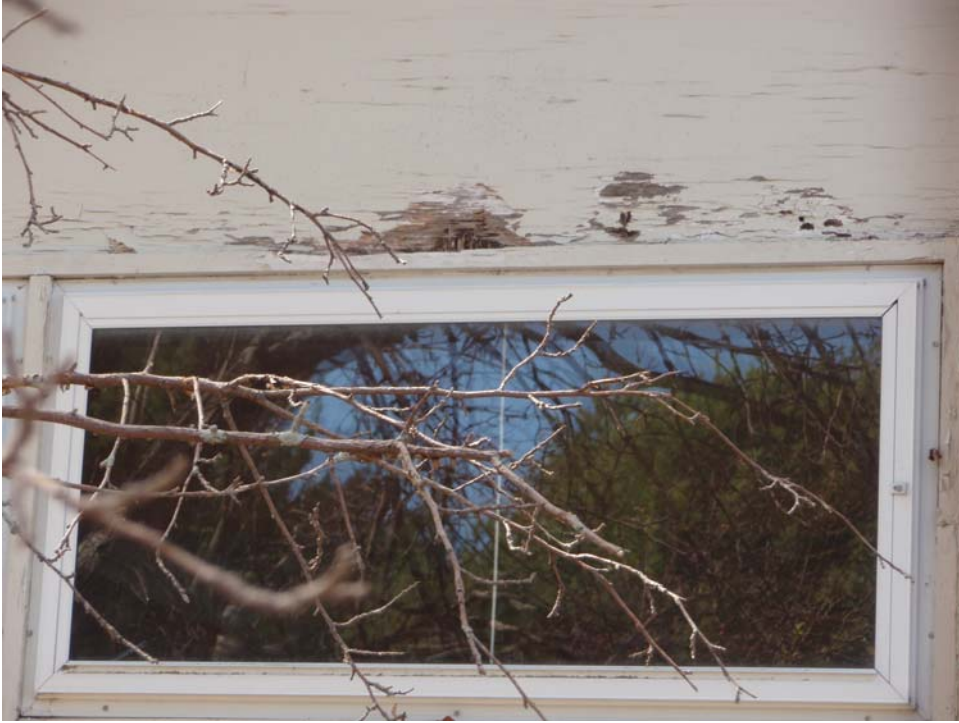
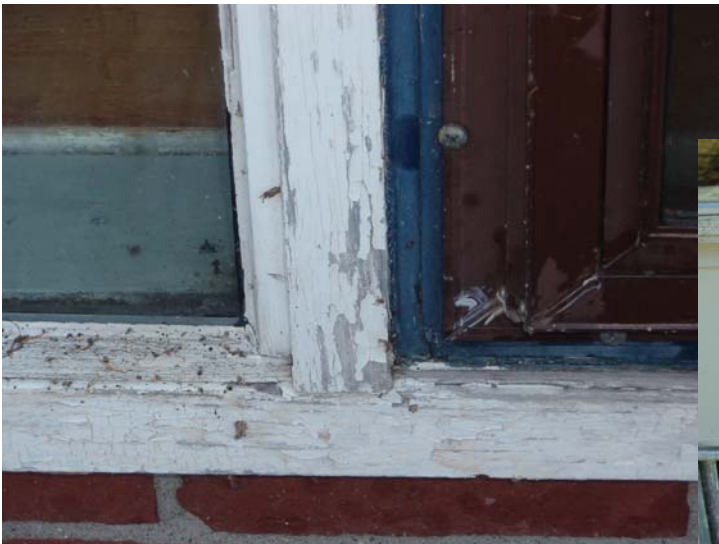
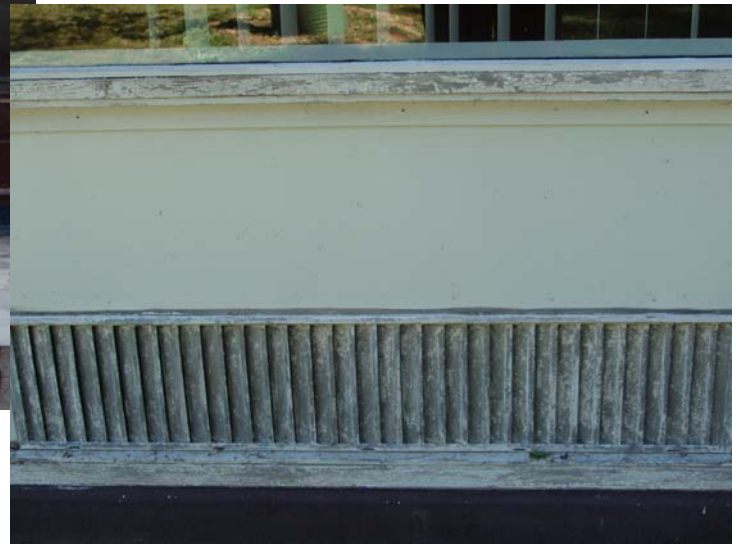
5. Exterior Window Walls. The glazed exterior curtain wall in the Brooks Building and a significant portion of the Smith Building are wood or wood with Transite panels. Double glazing has failed, wood has rotted and operable windows leak air. Pictures 1.51 through 1.53 indicate the condition of the curtain walls.

Pictures 1.51 through 1.53. Condition of Brooks window curtain walls, showing deteriorated panels and rotting trim.

5. Exterior Window Walls. Storm windows were installed some time ago over the single-glazed windows. A five-year cycle of painting wood framing and trim was re-started. Obvious cracks are re-caulked during the process. Damaged portions of the window walls are replaced with modern, insulated store-front framing and double glazing, but a very small portion of the total requirement has been replaced.

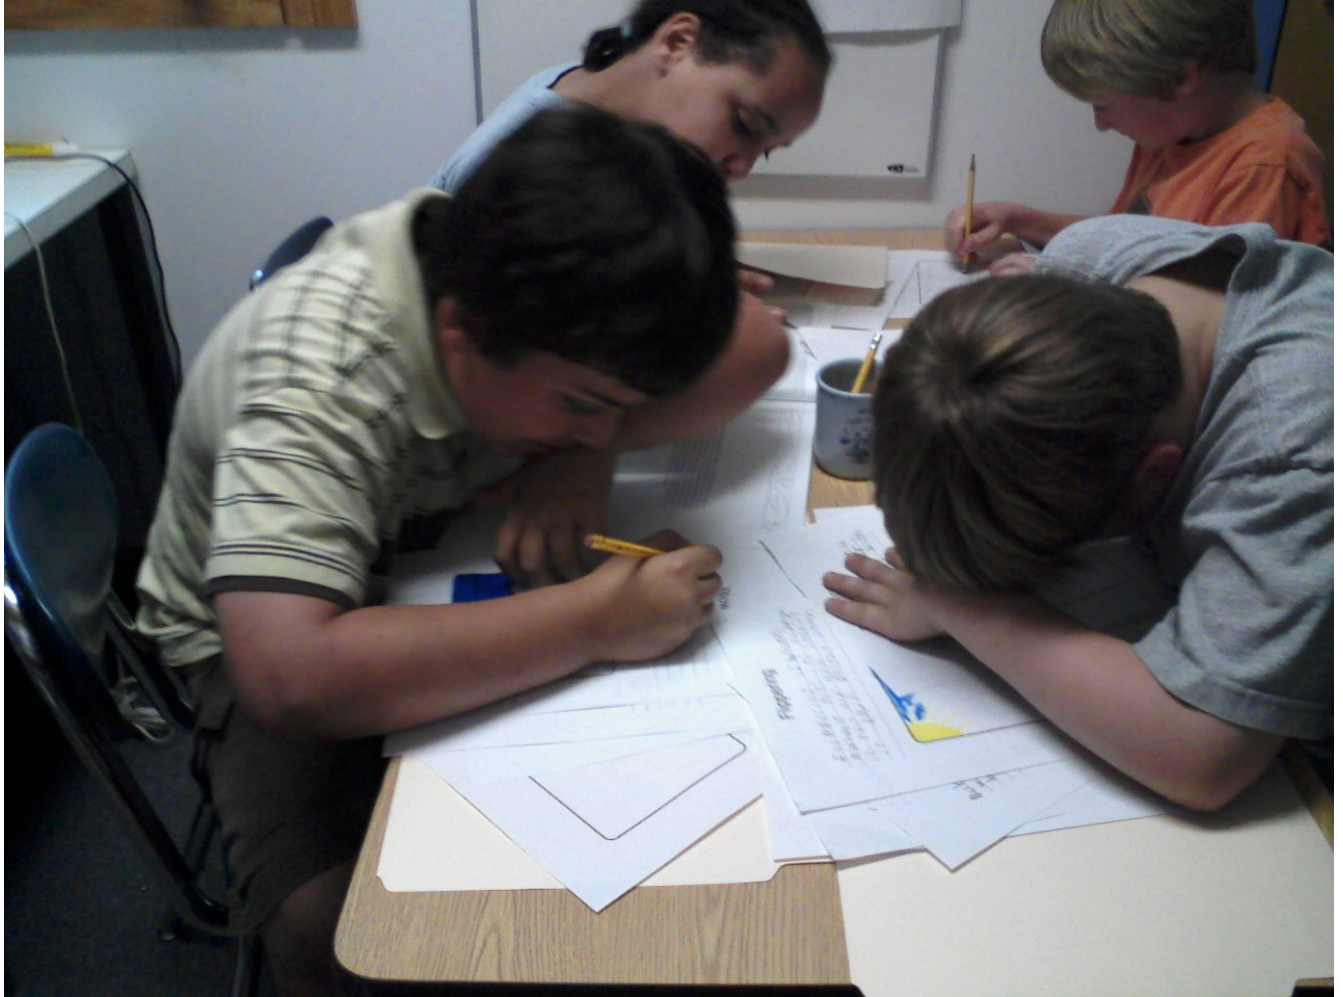
Picture 7.1 Special Education services delivered in inadequate area.
