TOWN OF LINCOLN

Statement of Interest for the Lincoln School, Lincoln, MA

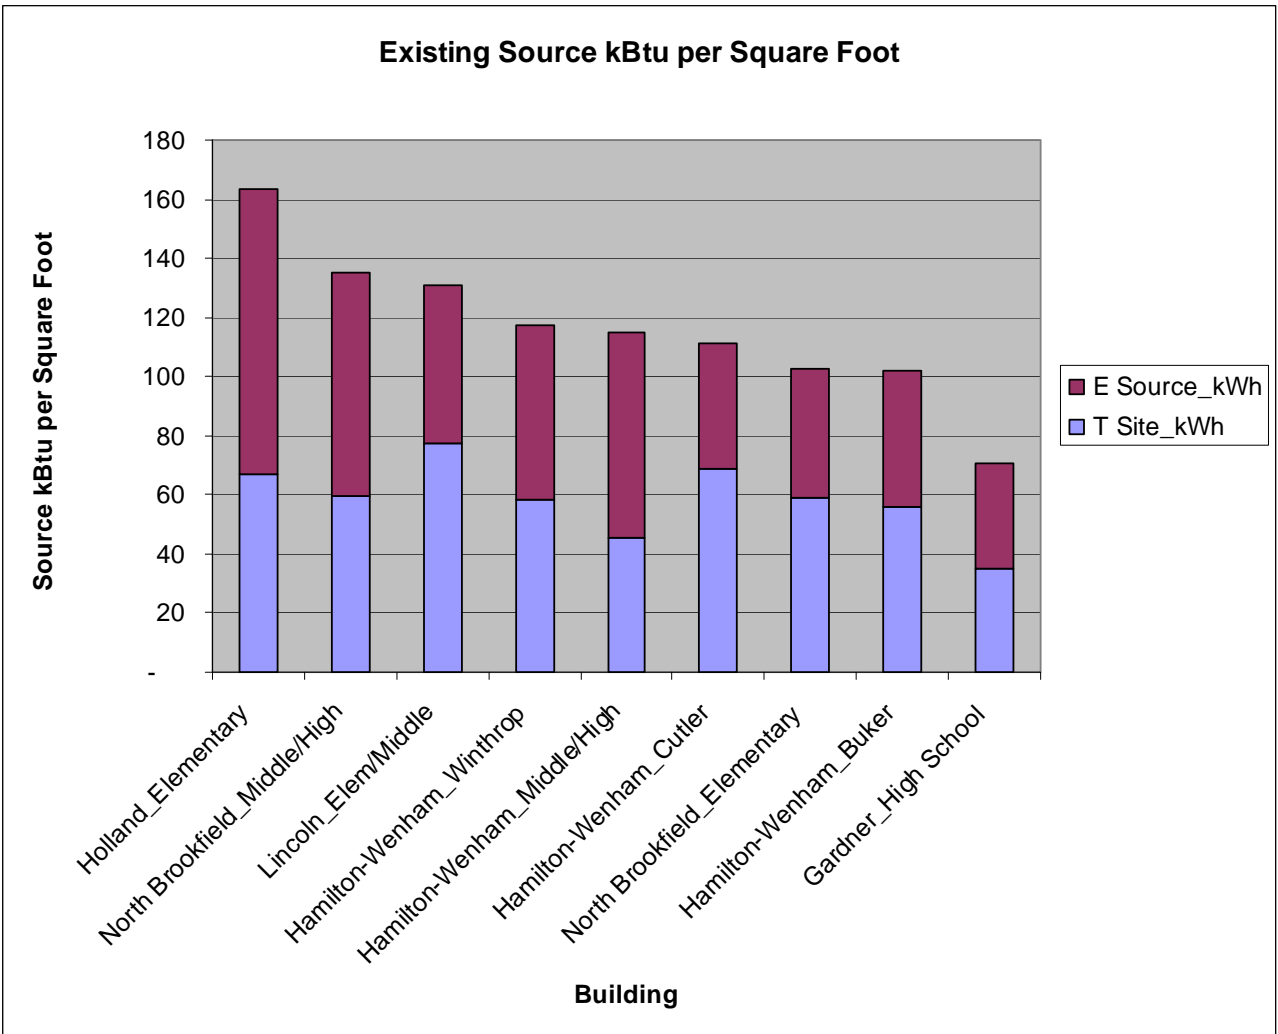
Figure 5.1 summarizes the energy performance of eight school buildings that received energy audits recently as part of MA DOER's Municipal Energy Audit Program, and the Lincoln School. As figure 5.1 indicates the Lincoln school complex has the highest thermal energy use per square foot (blue portion of the columns) of the nine studied buildings.

Figure 5.1 Source kBtu per Square Foot for nine Massachusetts school buildings. Blue bar shows thermal energy use per square foot.
